TL  
242  
.E6546  
1989

U.S. Department  
of Transportation  
**National Highway  
Traffic Safety  
Administration**

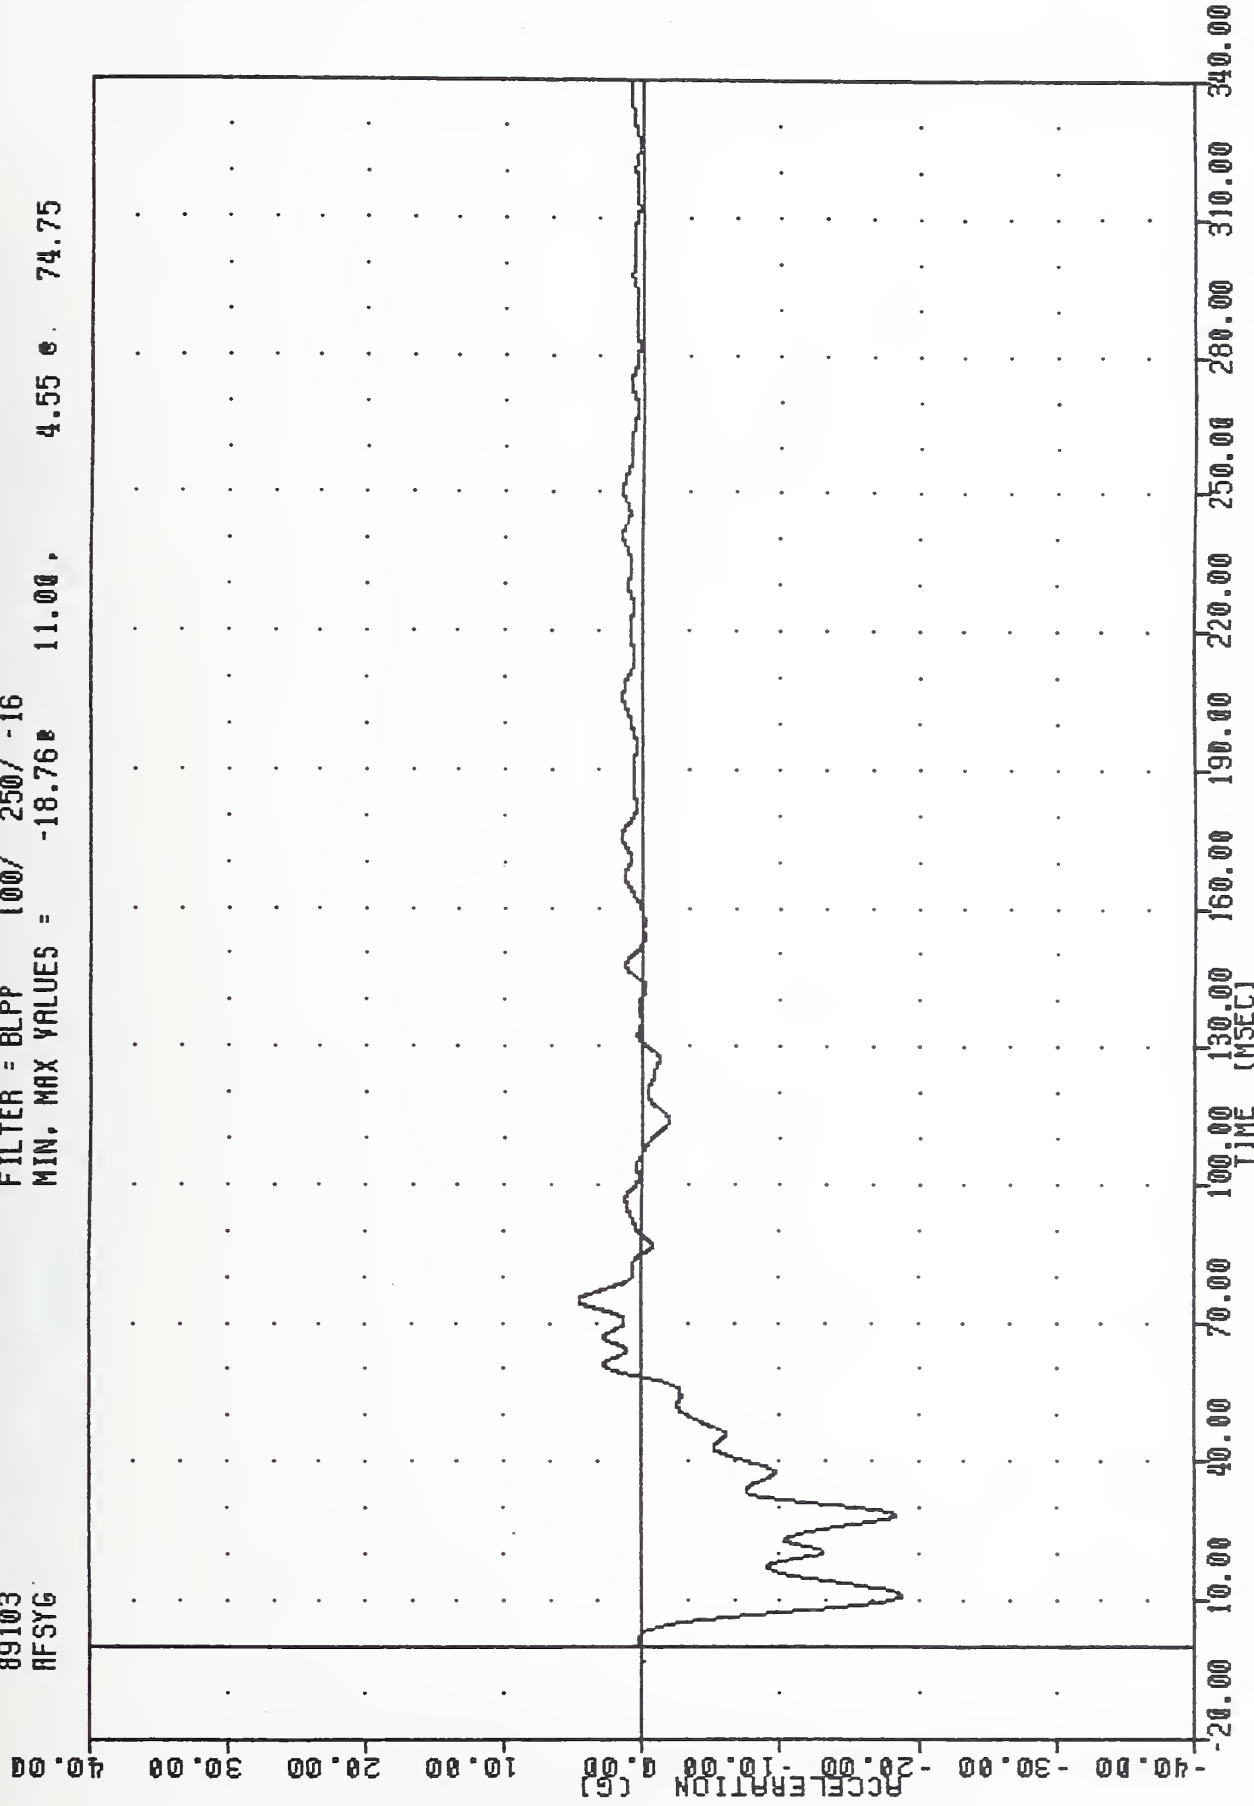
CONTOURED BARRIER INTO 90 DEG 1985 CHEVROLET CELEBRITY AT 20.3 MPH #1  
VEHICLE RIGHT FRONT SILL Y AXIS ACCELERATION

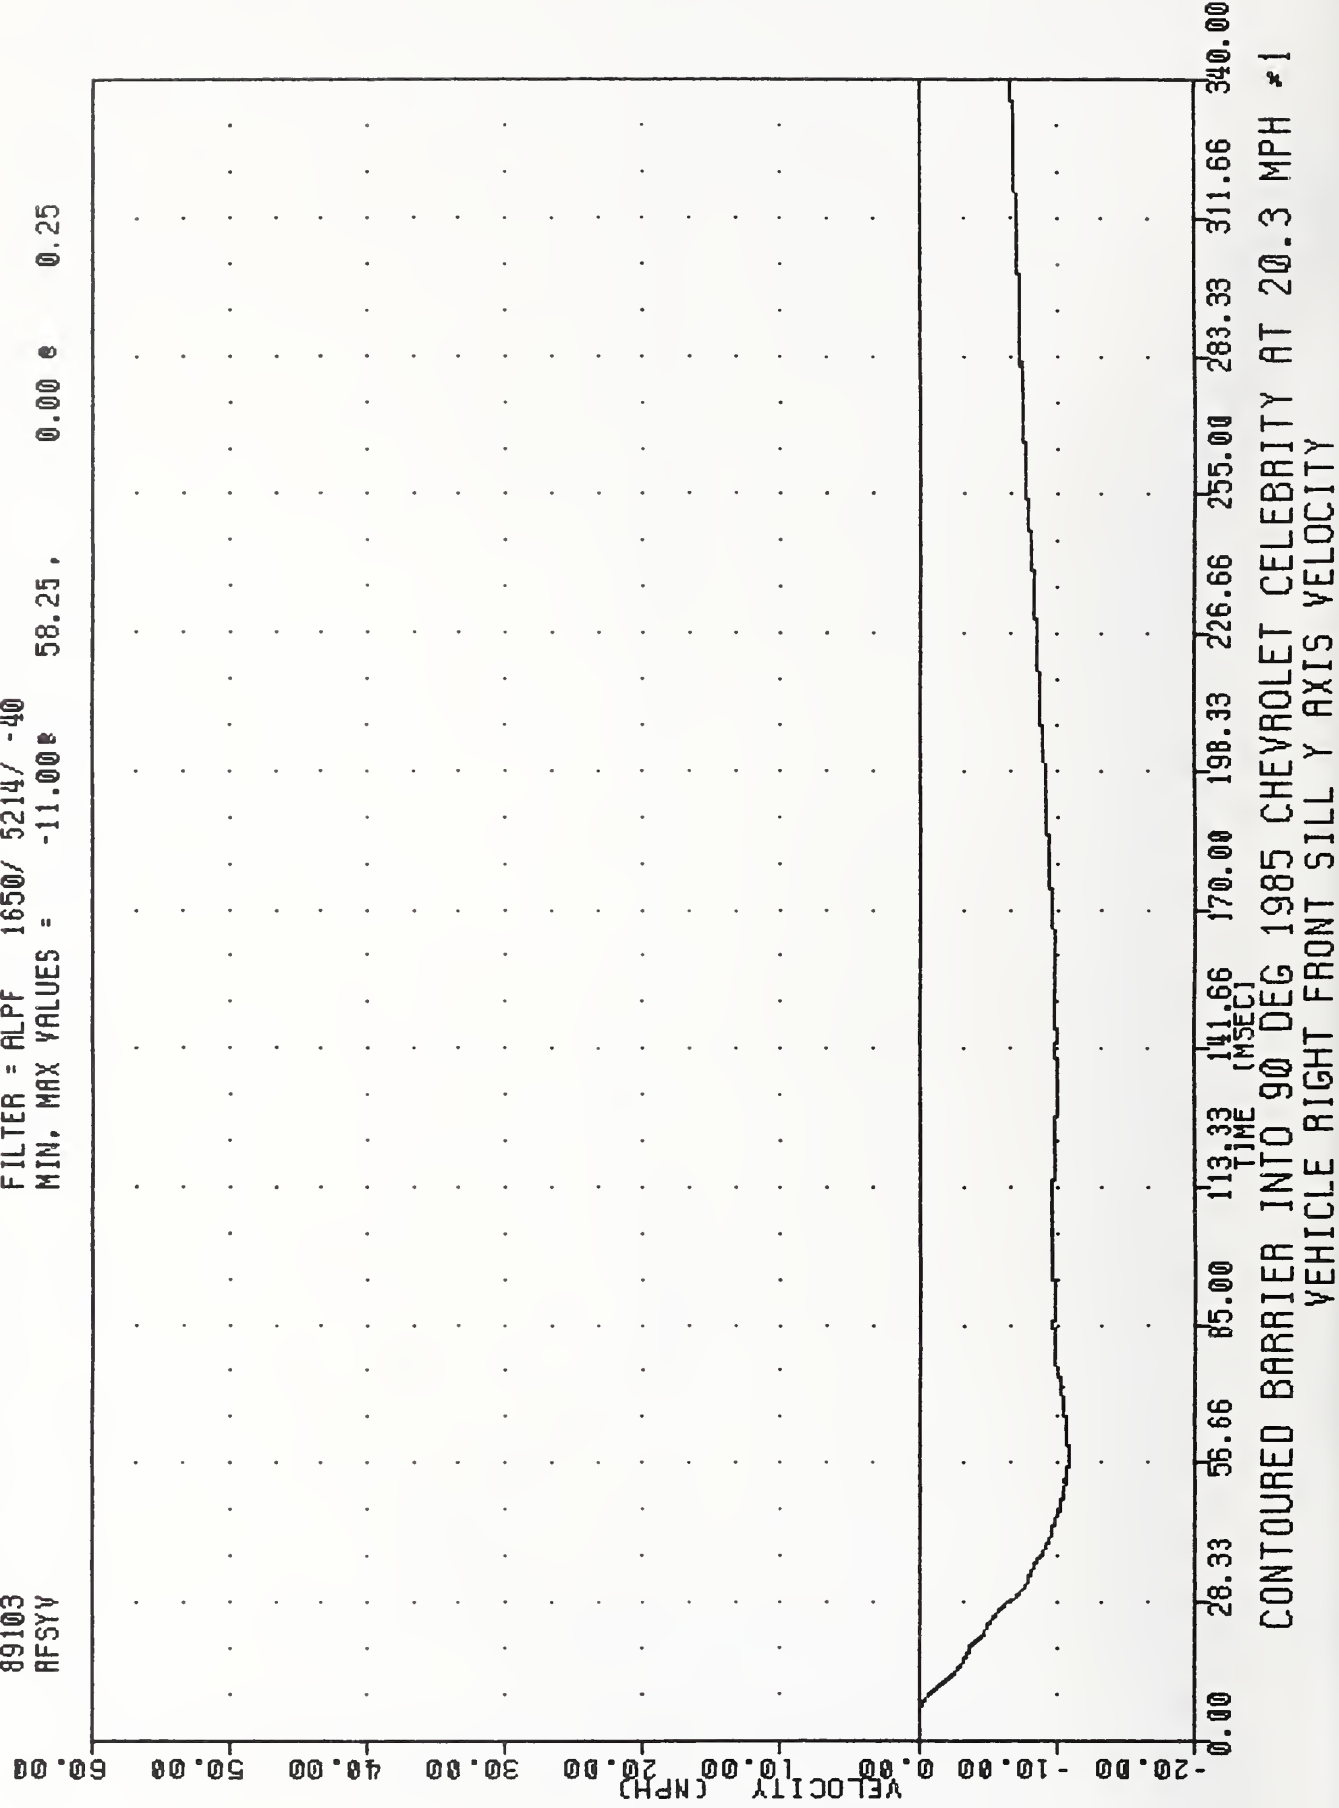
CONTOURED BARRIER INTO 90 DEG 1985 CHEVROLET CELEBRITY AT 20.3 MPH #1  
 VEHICLE RIGHT FRONT SILL Y AXIS VELOCITY

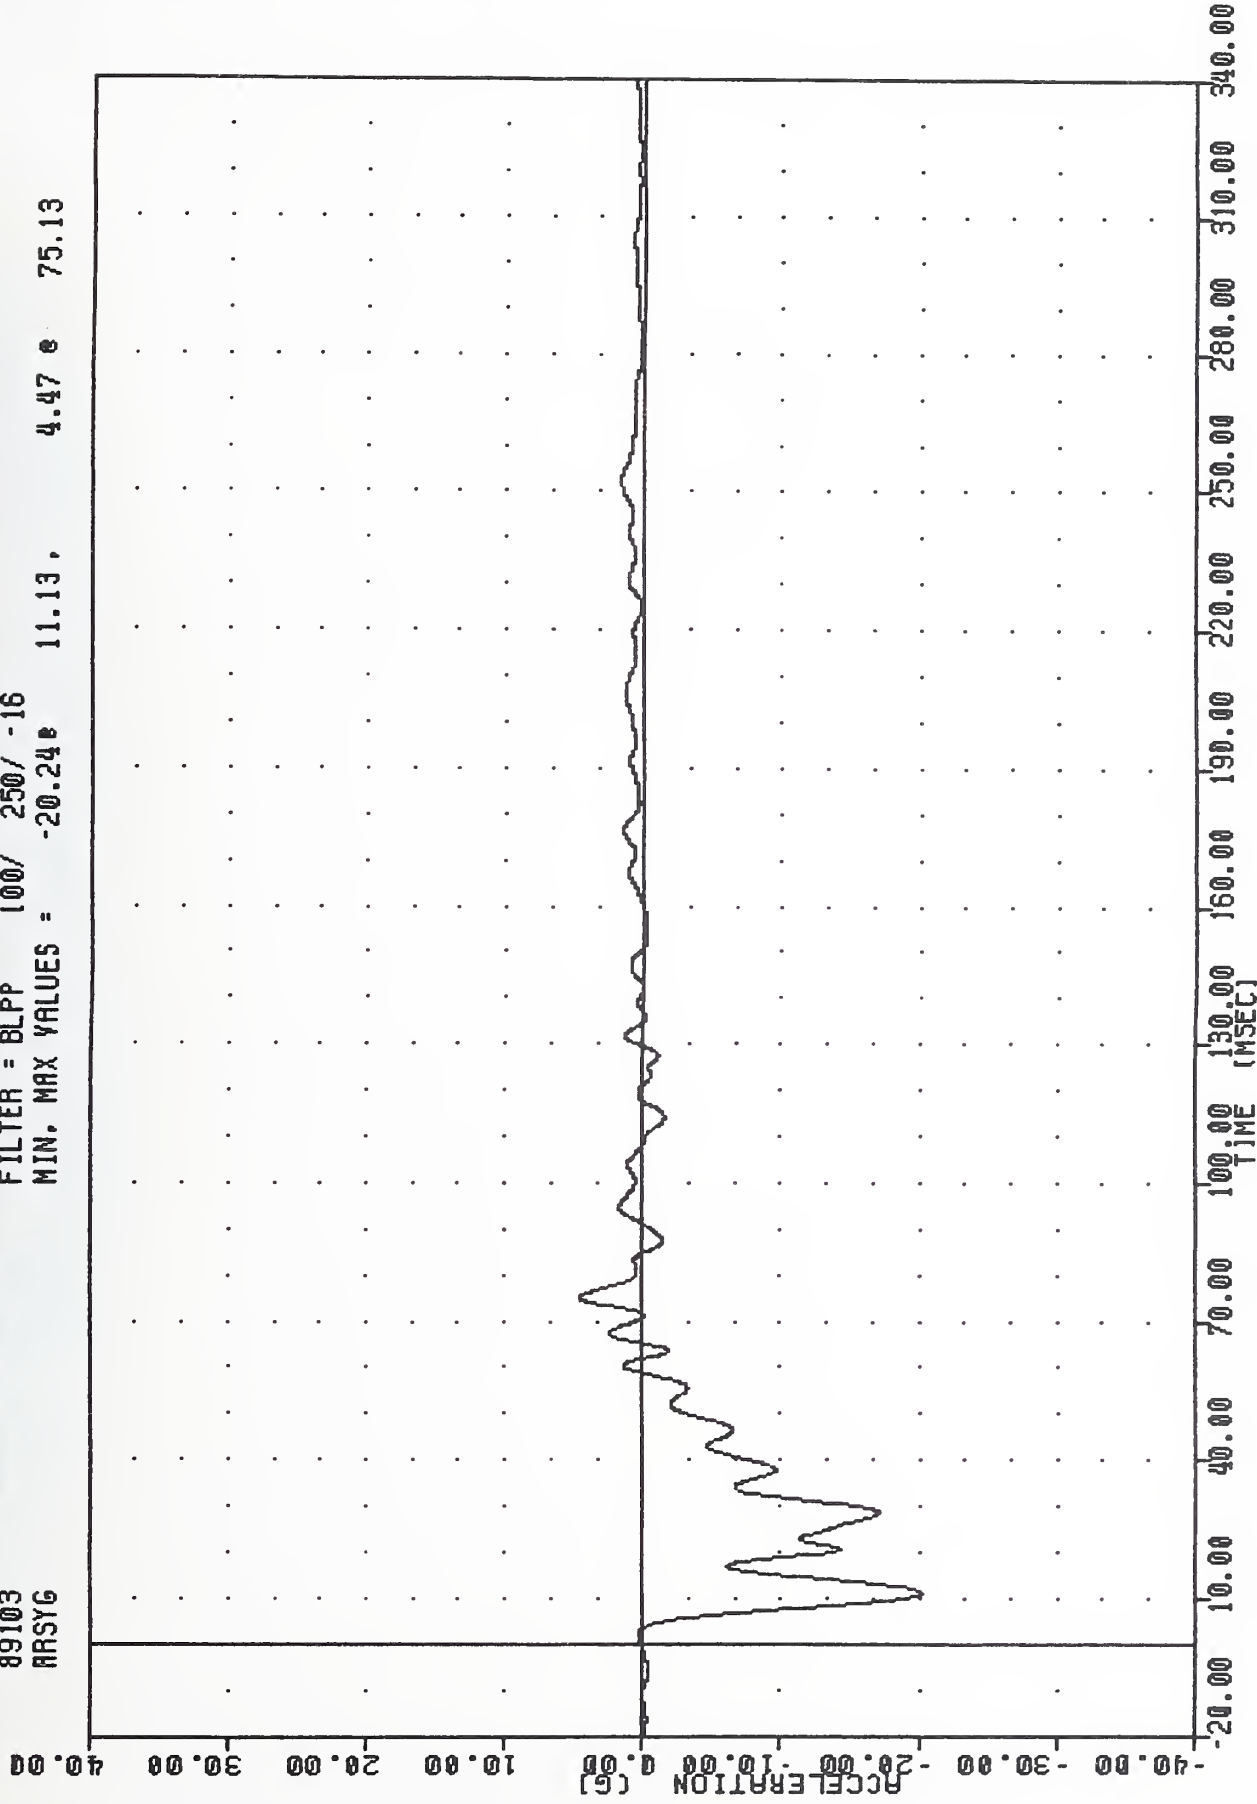
CONTOURED BARRIER INTO 90 DEG 1985 CHEVROLET CELEBRITY AT 20.3 MPH #1  
VEHICLE RIGHT REAR SILL Y AXIS ACCELERATION

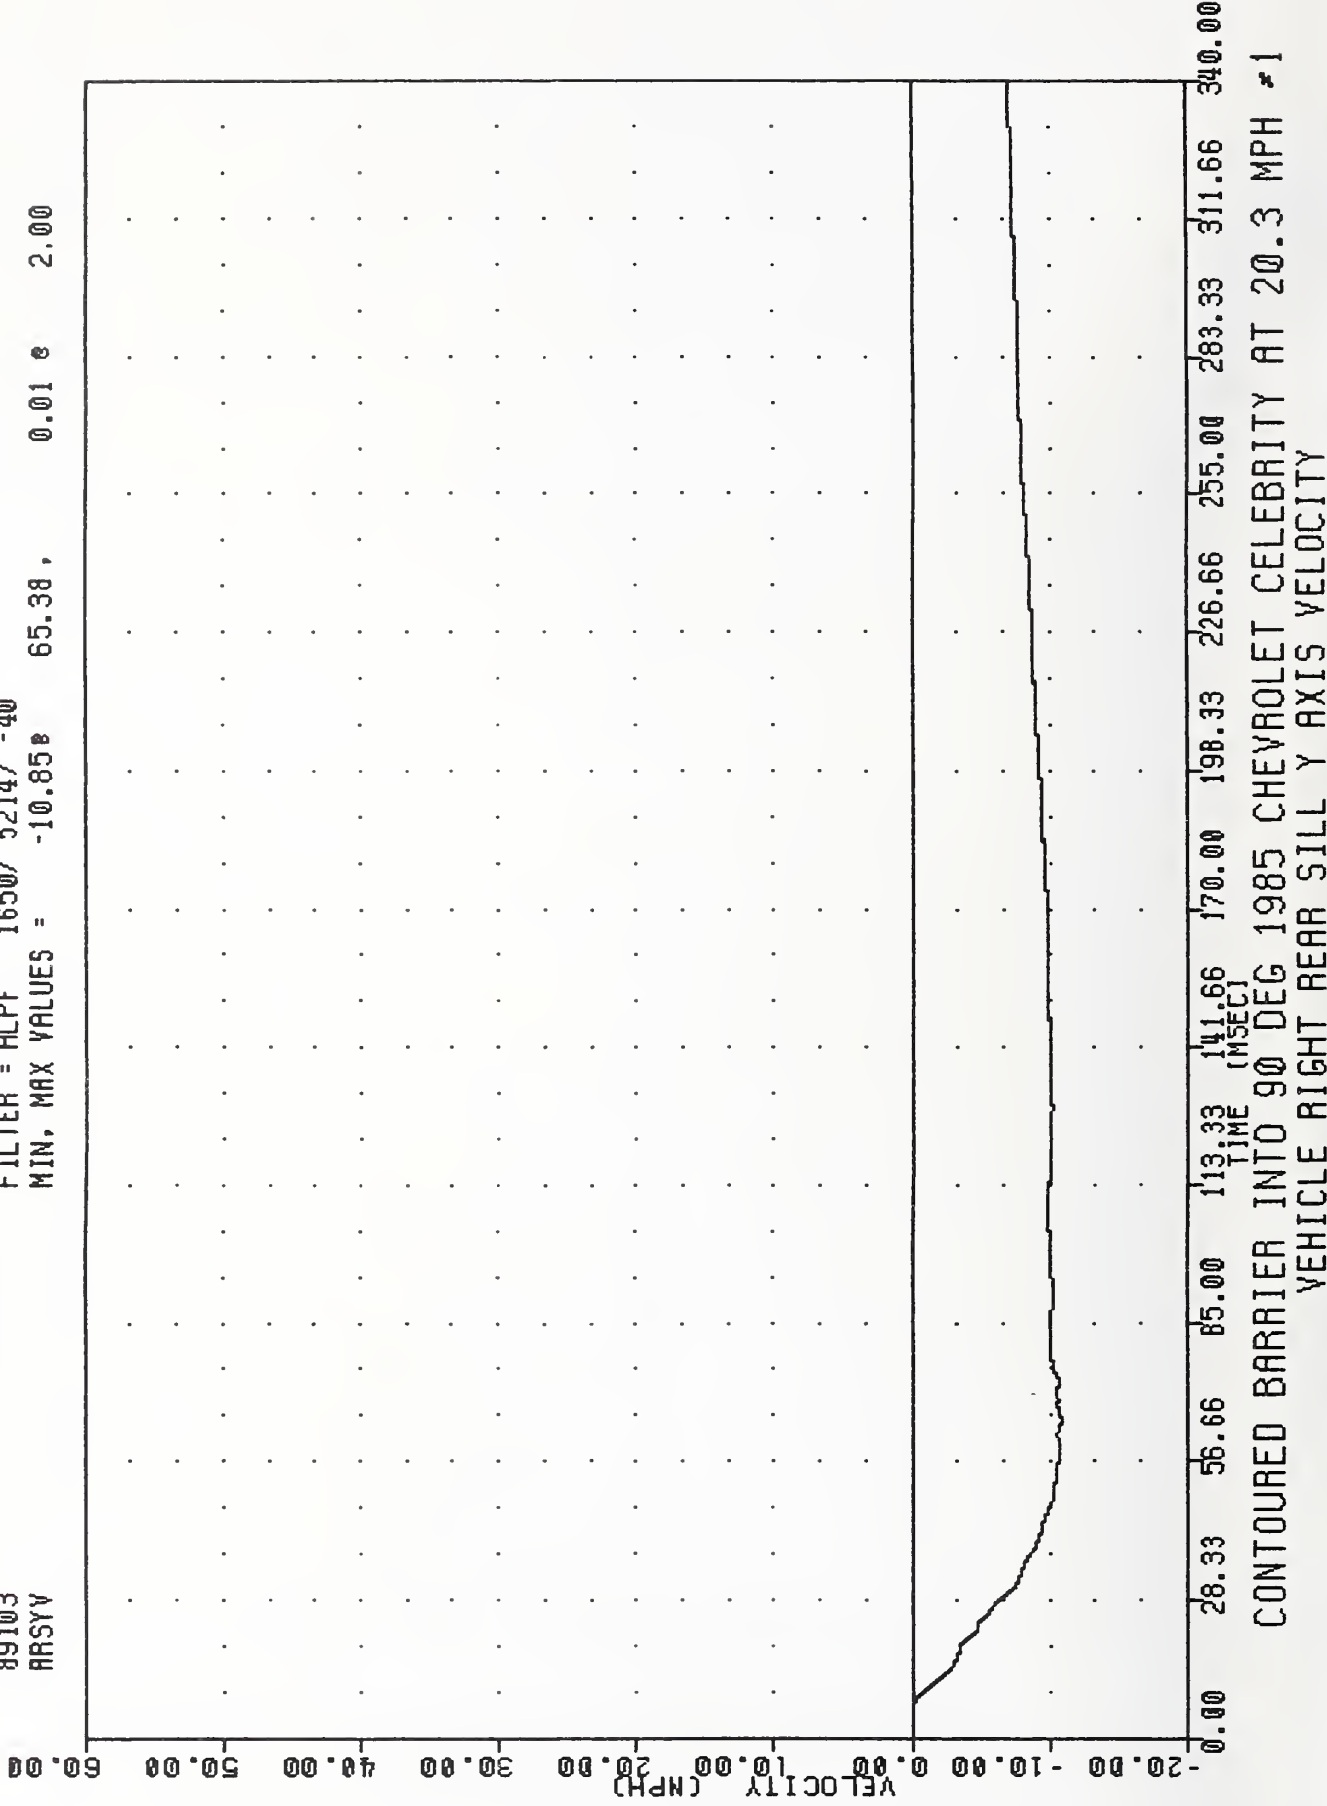
VRTC-1 , 890413-1  
CRASH III DAMAGE ALGORITHM  
89103  
BCGXC

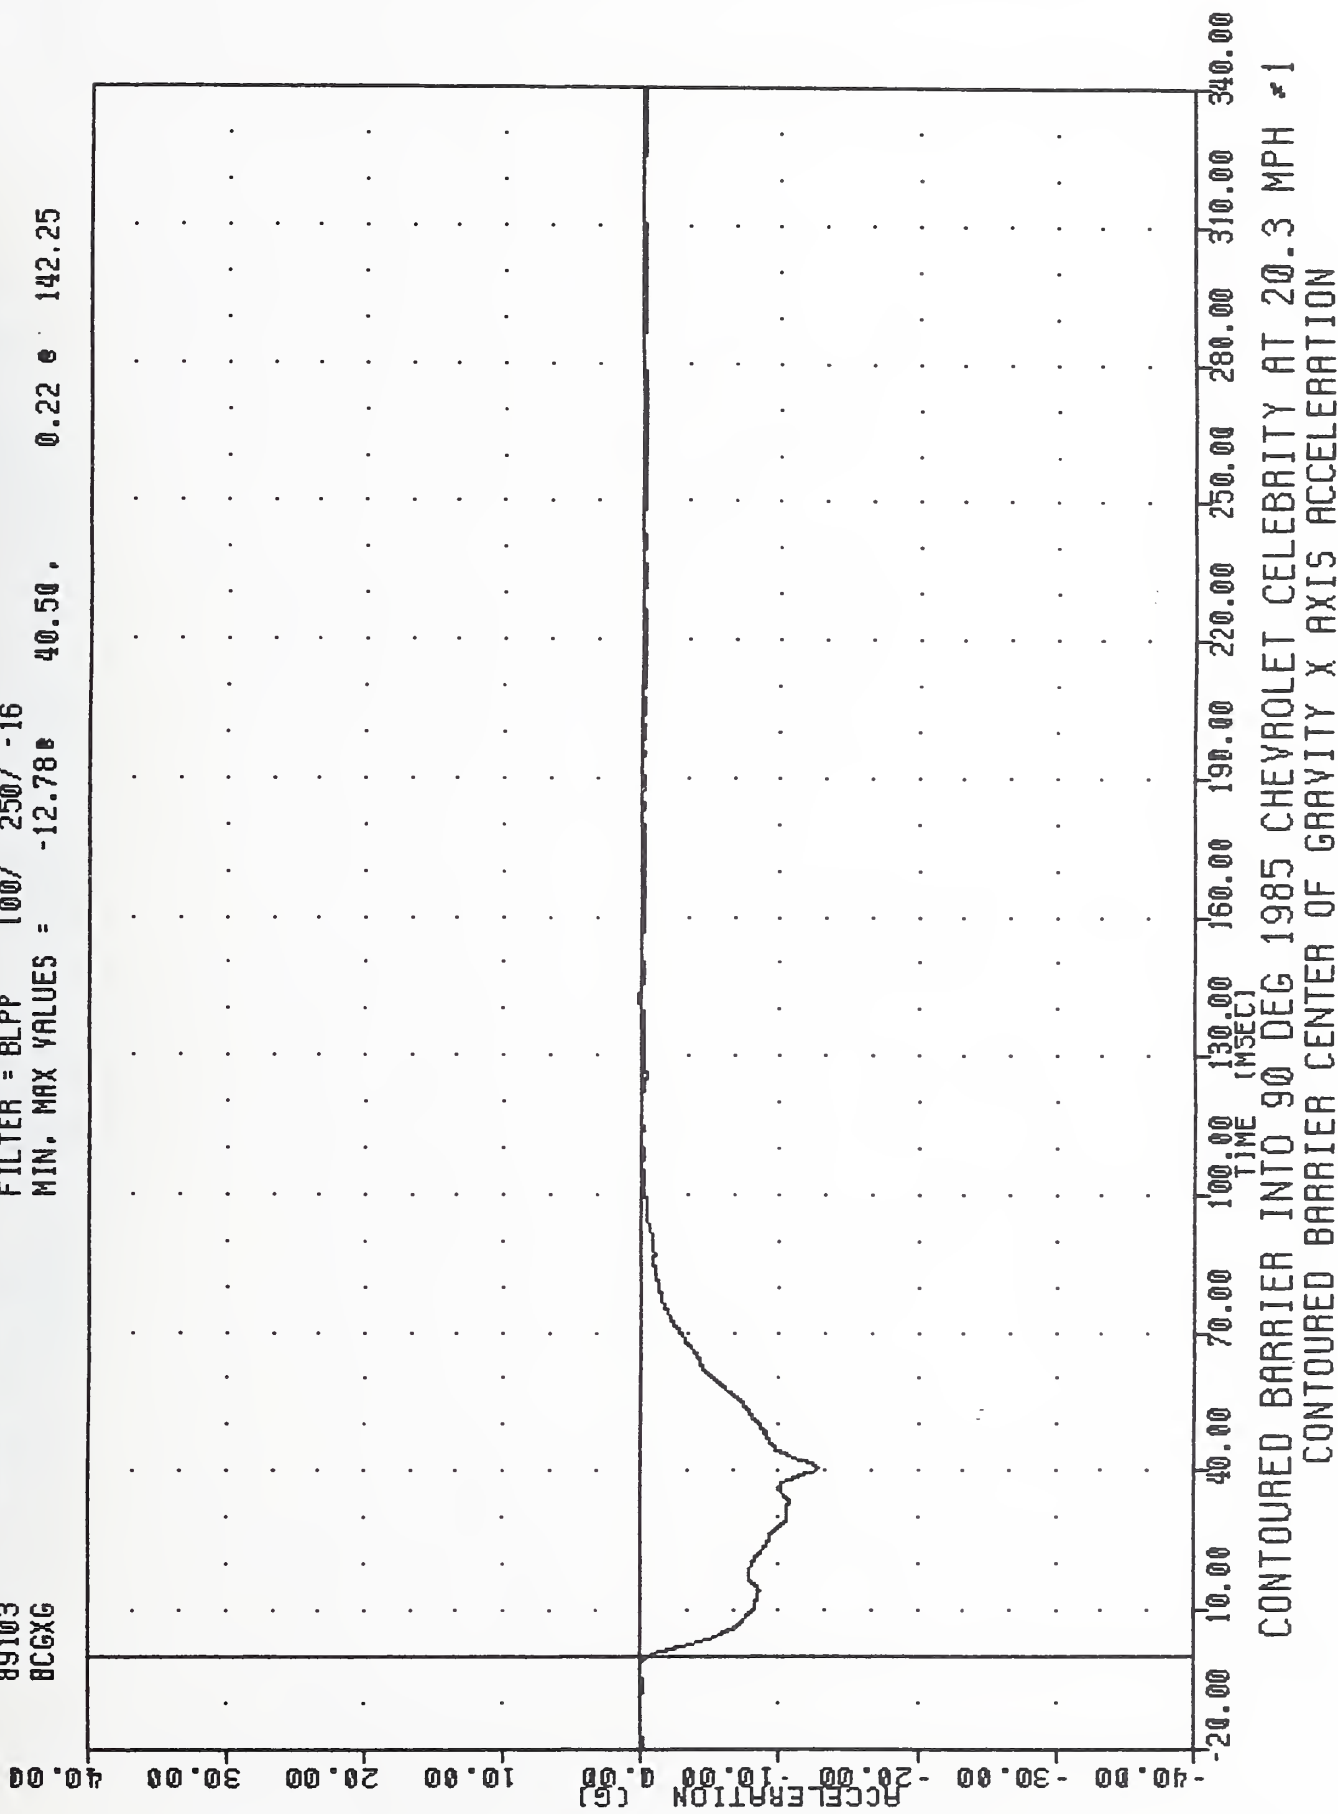
VRTC-1 , 890413-1  
 CRASH III DAMAGE ALGORITHM  
 89103  
 BCGXY

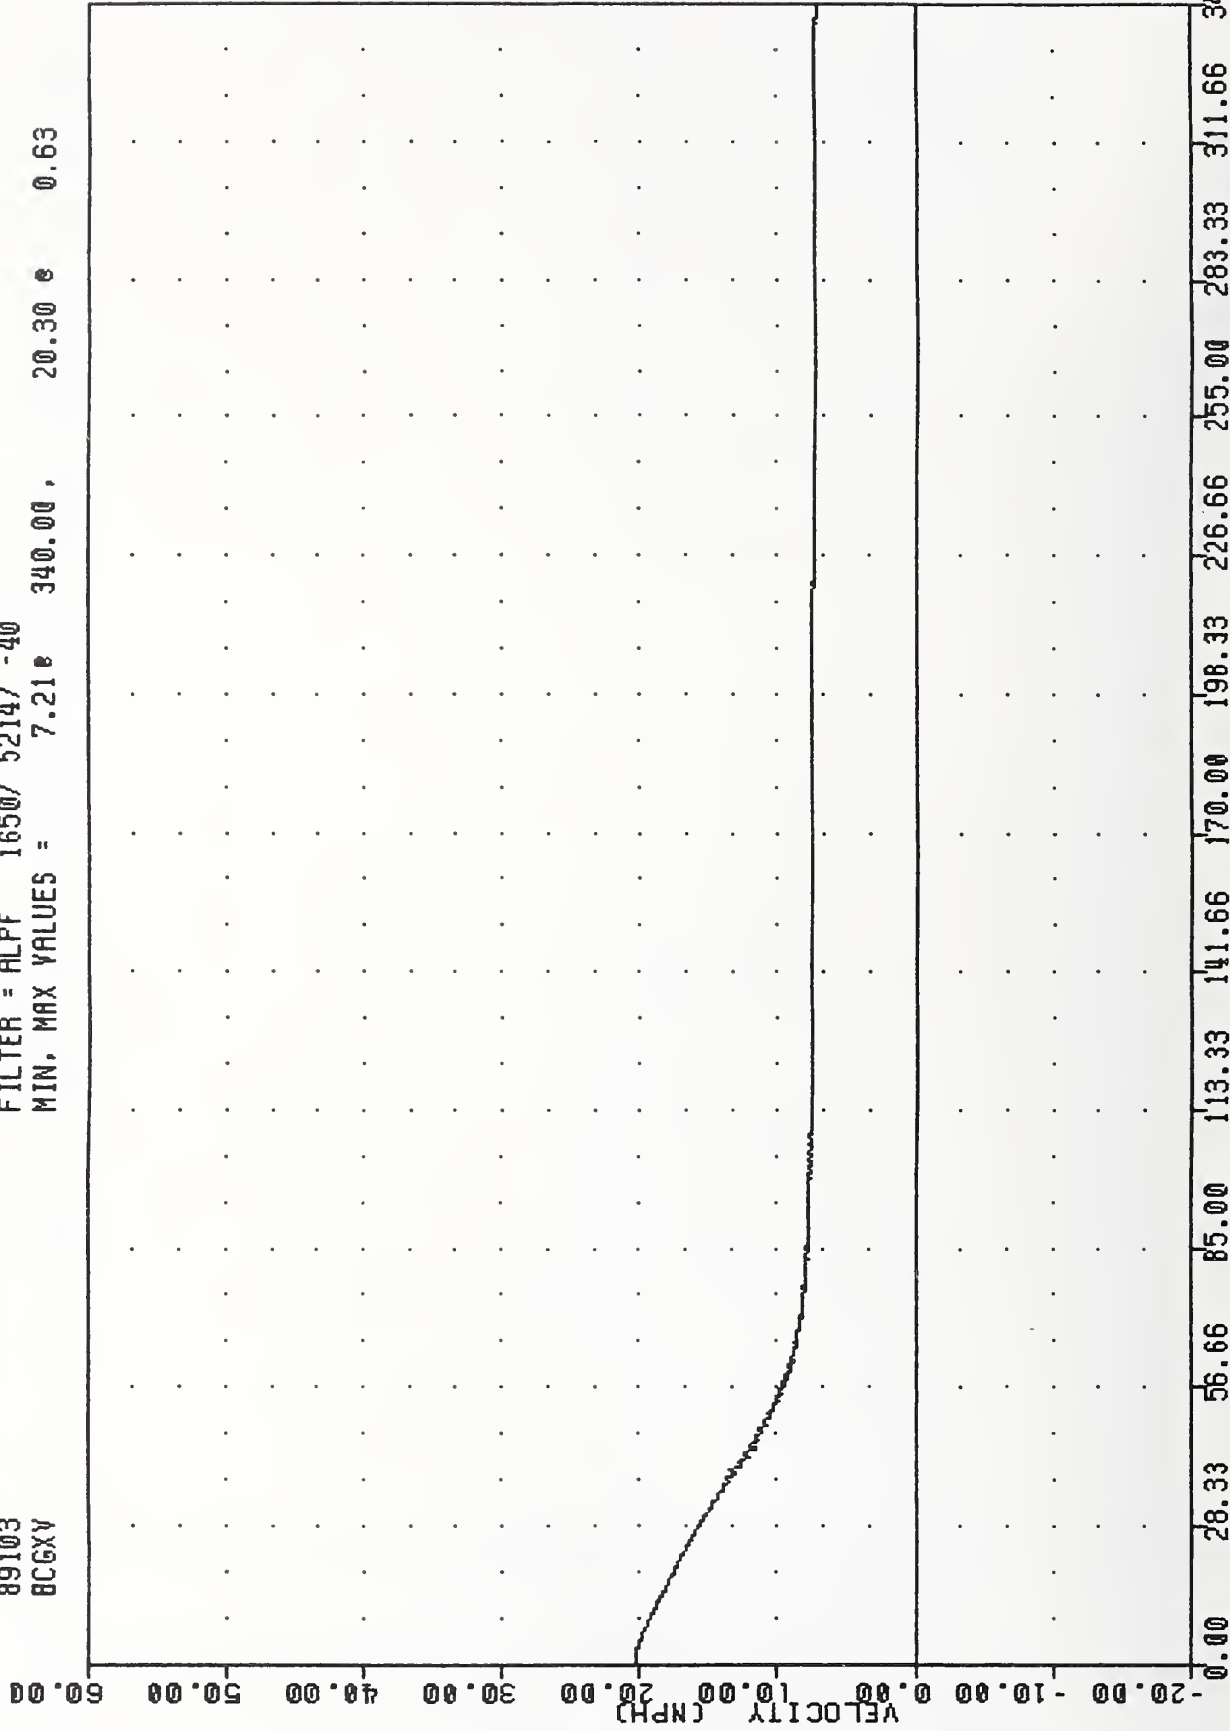
CONTOURED BARRIER INTO 90 DEG 1985 CHEVROLET CELEBRITY AT 20.3 MPH #1  
 CONTOURED MOVING BARRIER CENTER OF GRAVITY X AXIS VELOCITY

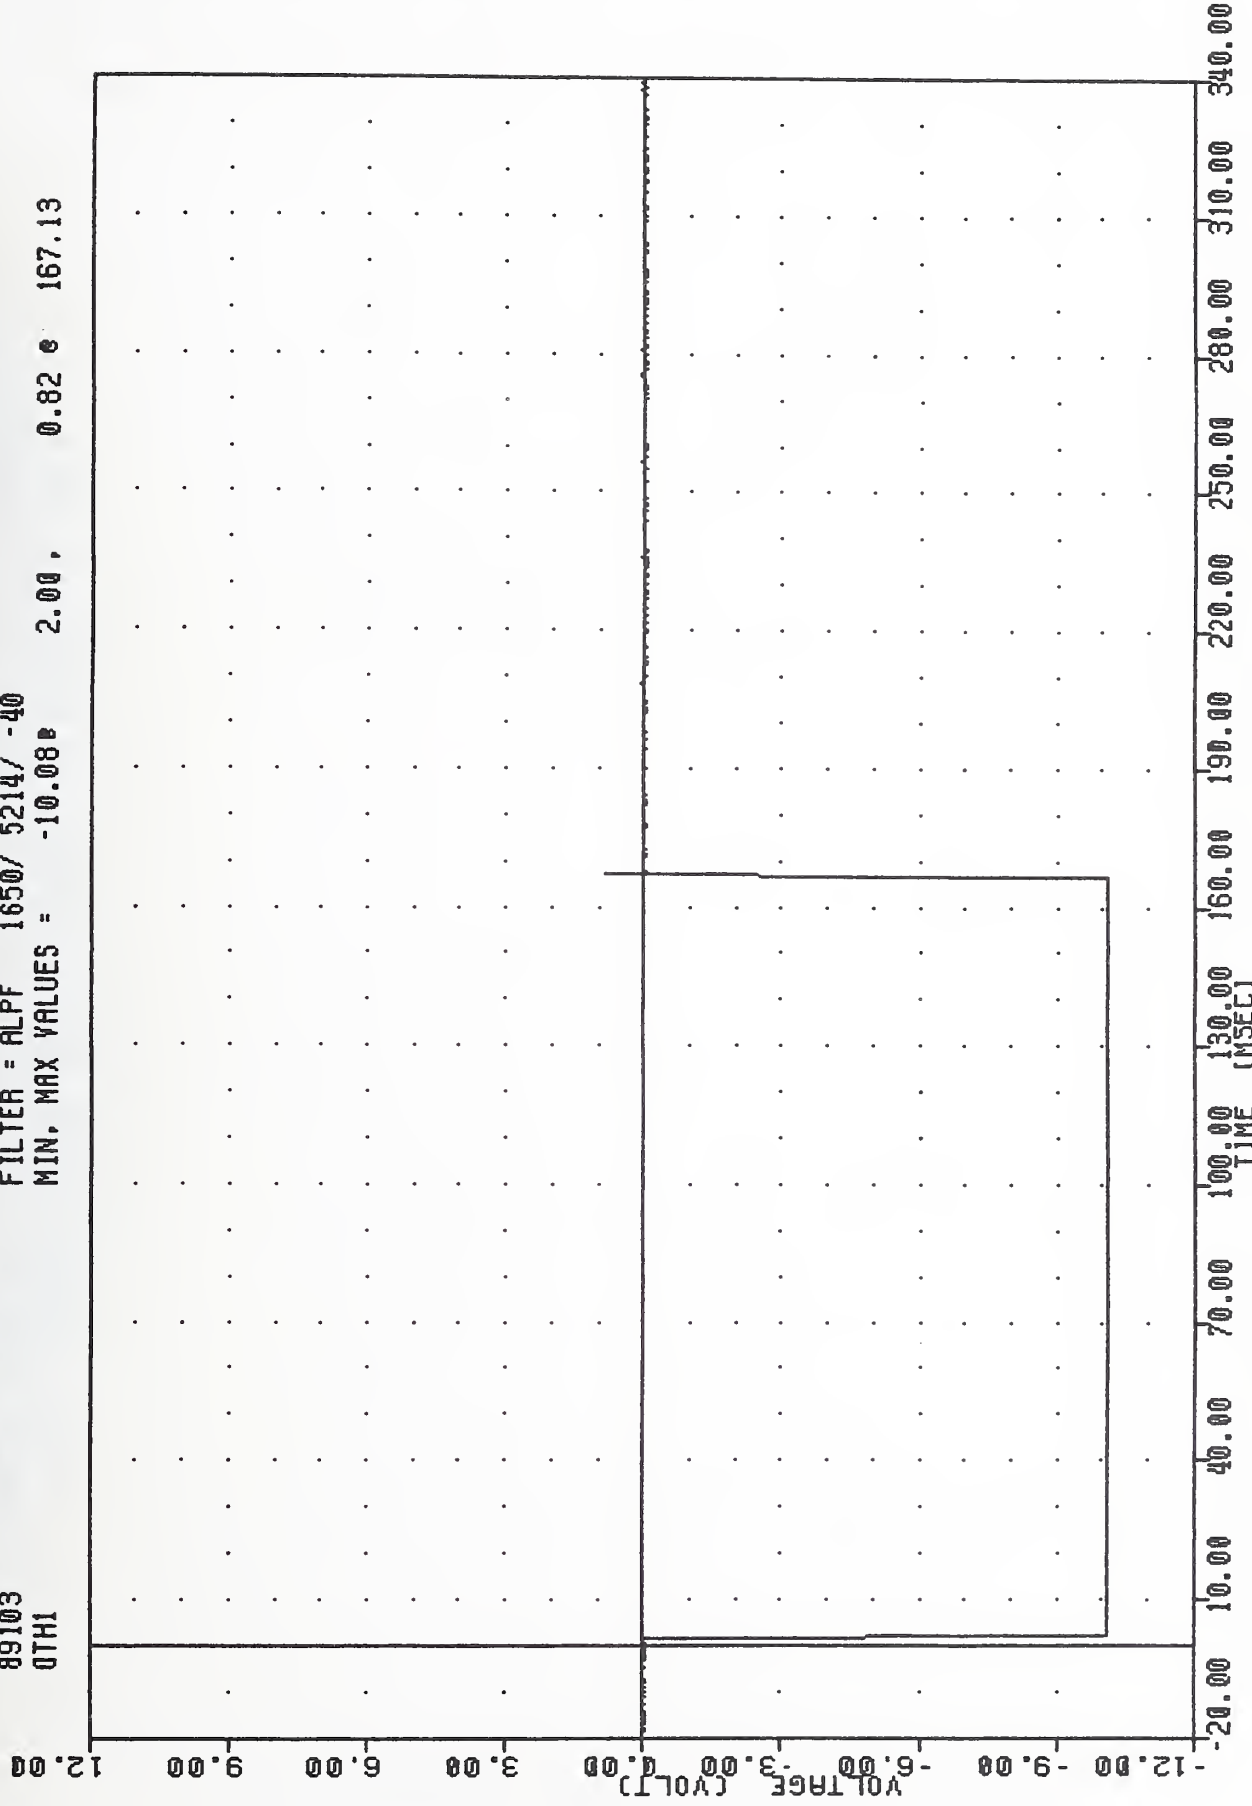
CONTOURED BARRIER INTO 90 DEG 1985 CHEVROLET CELEBRITY AT 20.3 MPH #1  
VEHICLE CONTACT SWITCH - FRONT

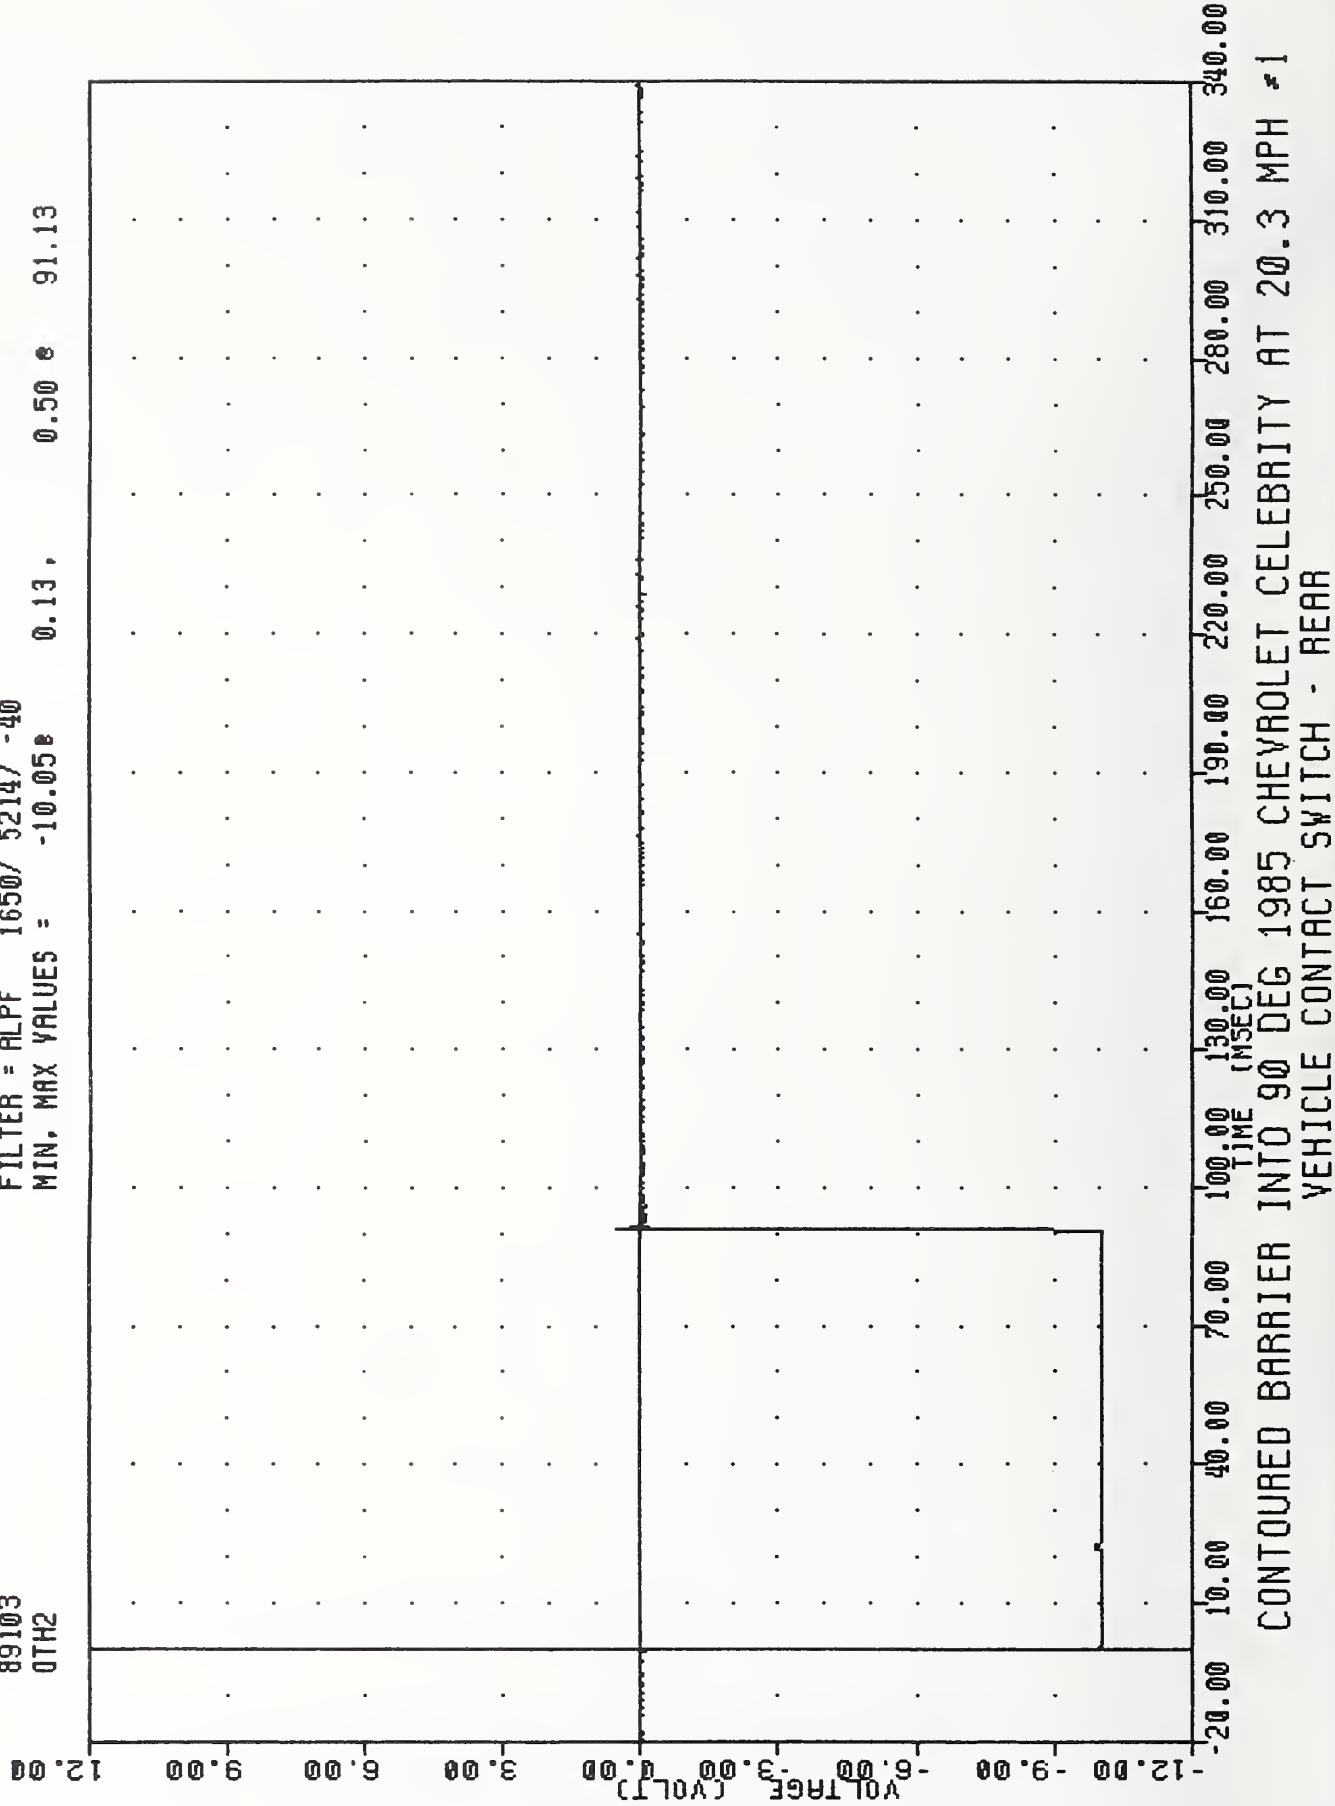
YRTC-1 , 890413-1  
CRASH III DAMAGE ALGORITHM  
89103  
0TH3

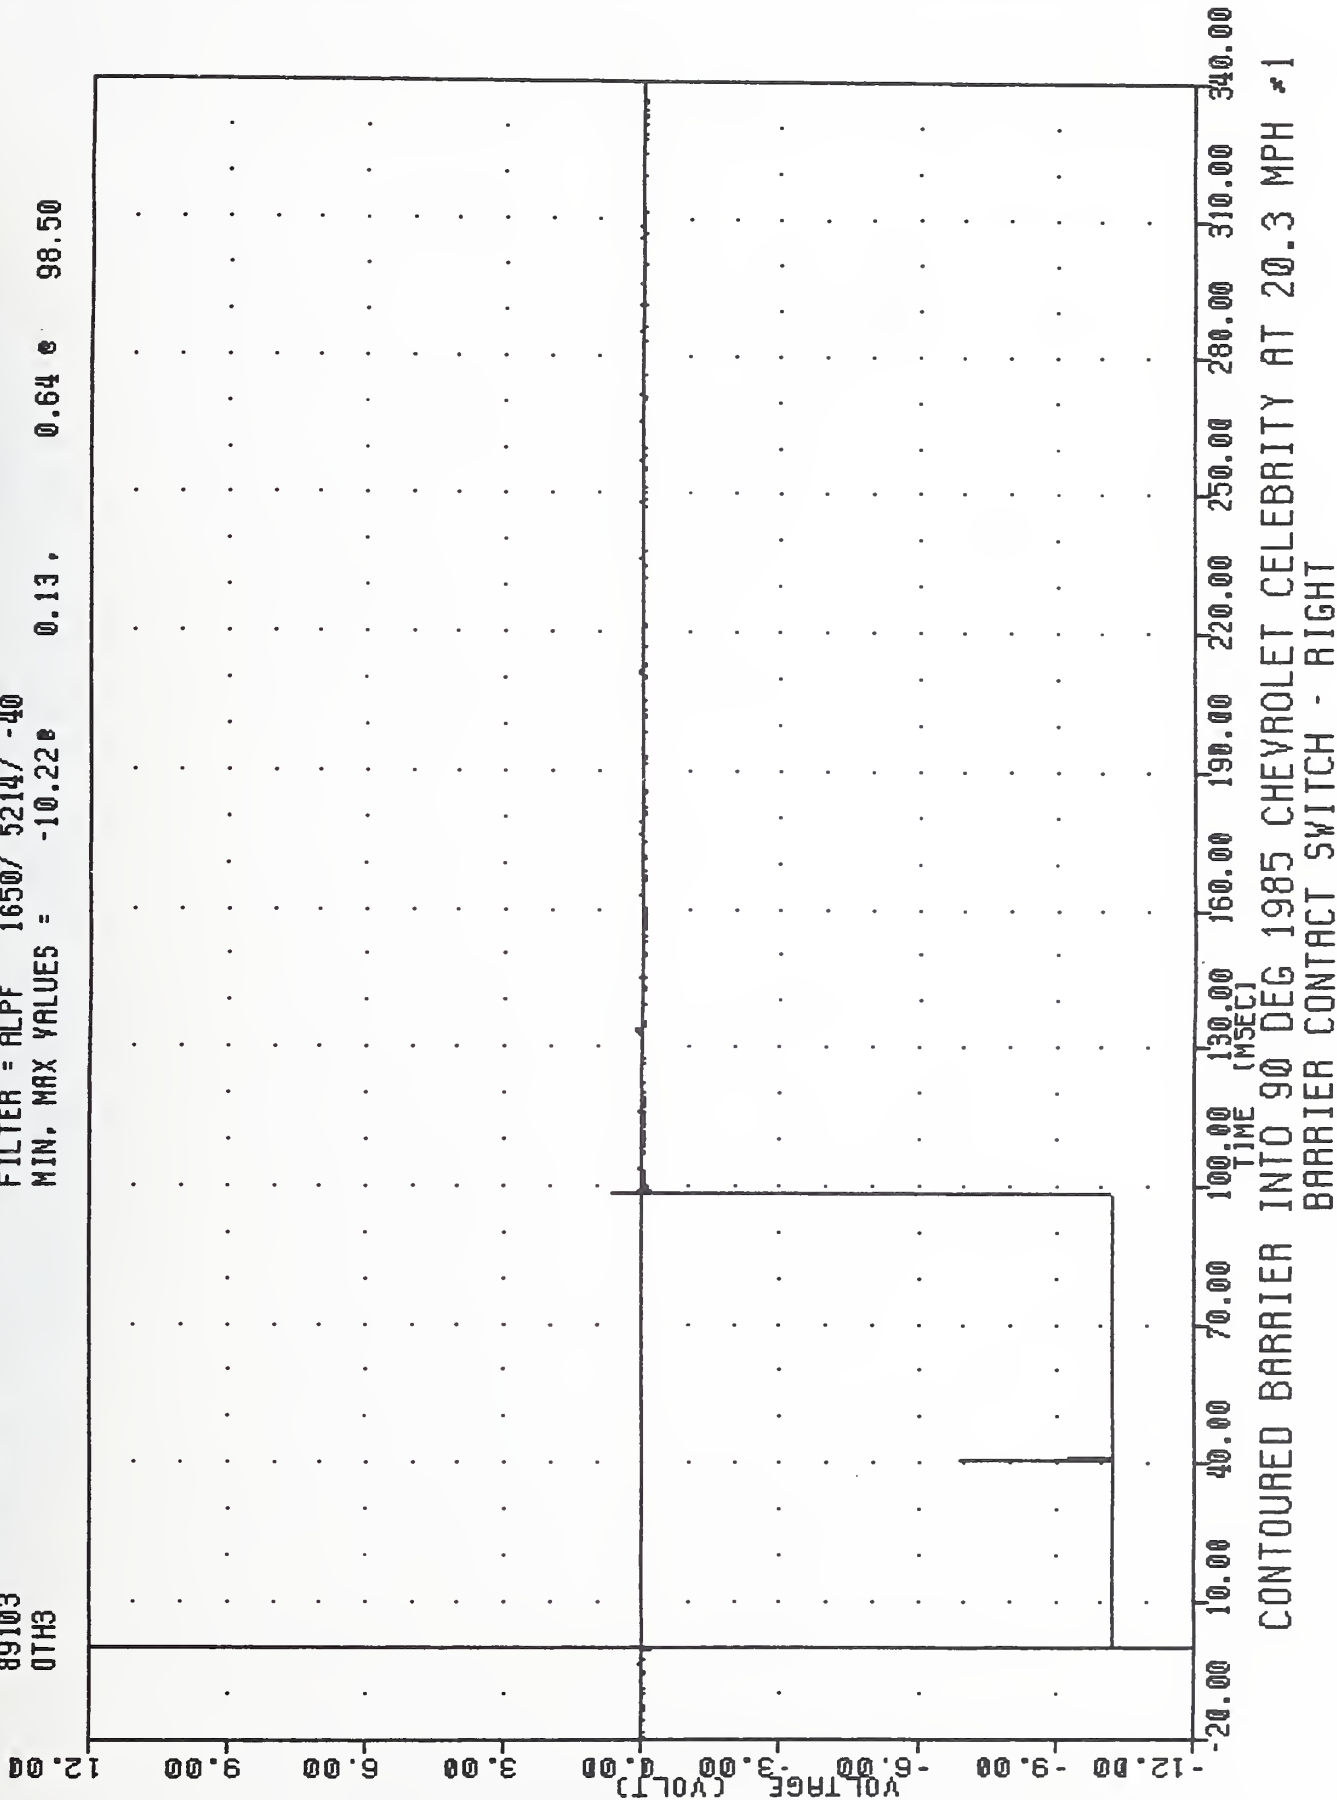
VRTC-1 , 890413-1  
CRASH III DAMAGE ALGORITHM  
89103  
0TH4
